# CHISANA

## HISTORIC STRUCTURE REPORT

THE U.S. COMMISSIONER'S COURT,  
THE U.S. COMMISSIONER'S RESIDENCE, AND THE WOMEN'S JAIL  
CHISANA HISTORIC DISTRICT  
WRANGELL-ST. ELIAS NATIONAL PARK & PRESERVE  
ALASKA

PREPARED BY  
CRAIG W. DAVIS, REGIONAL ARCHEOLOGIST  
DAVID E. SNOW, REGIONAL HISTORICAL ARCHITECT  
ROBERT L. S. SPUDE, REGIONAL HISTORIAN

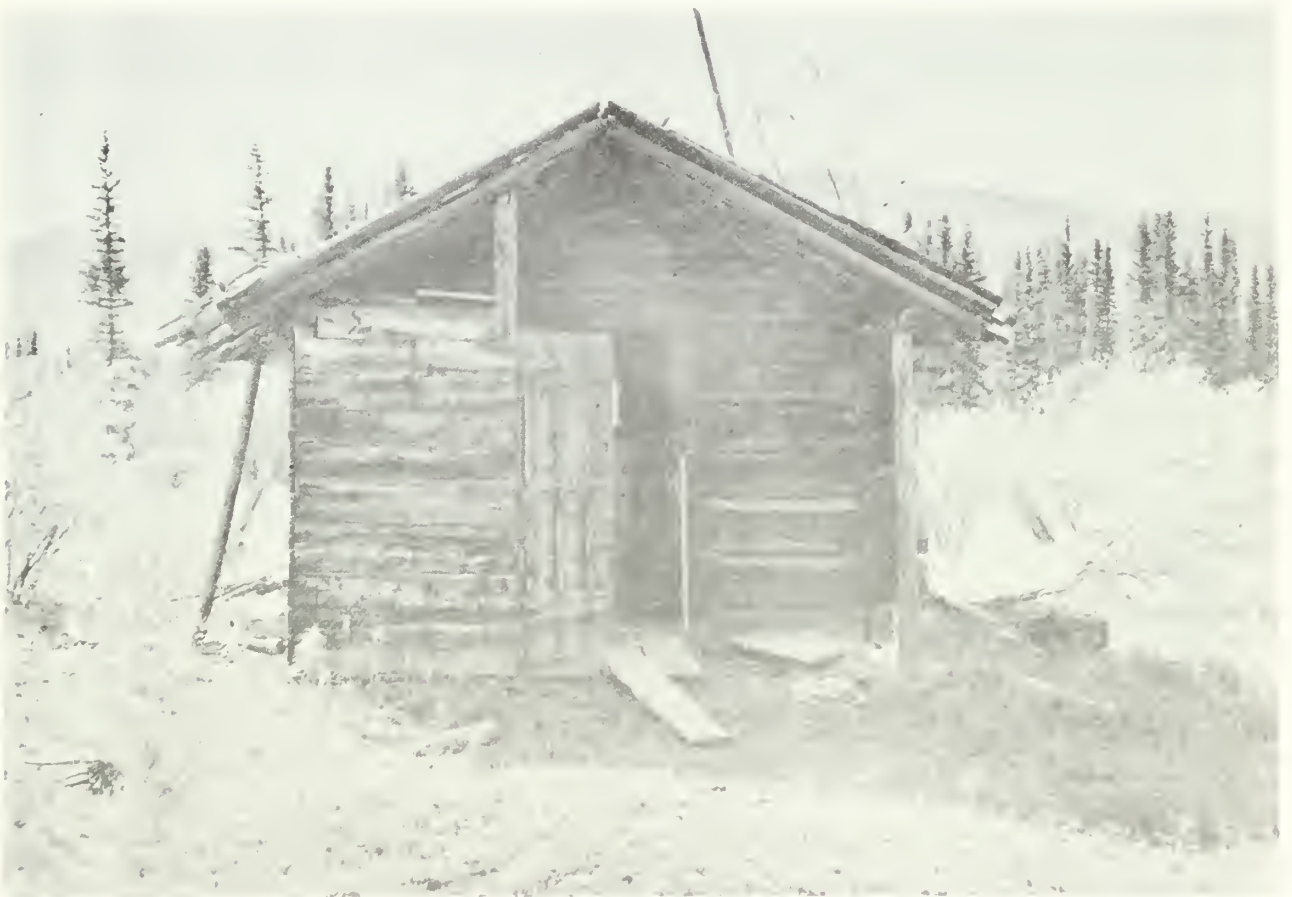
Photograph 2  
Women's Jail, Chisana  
East Elevation.

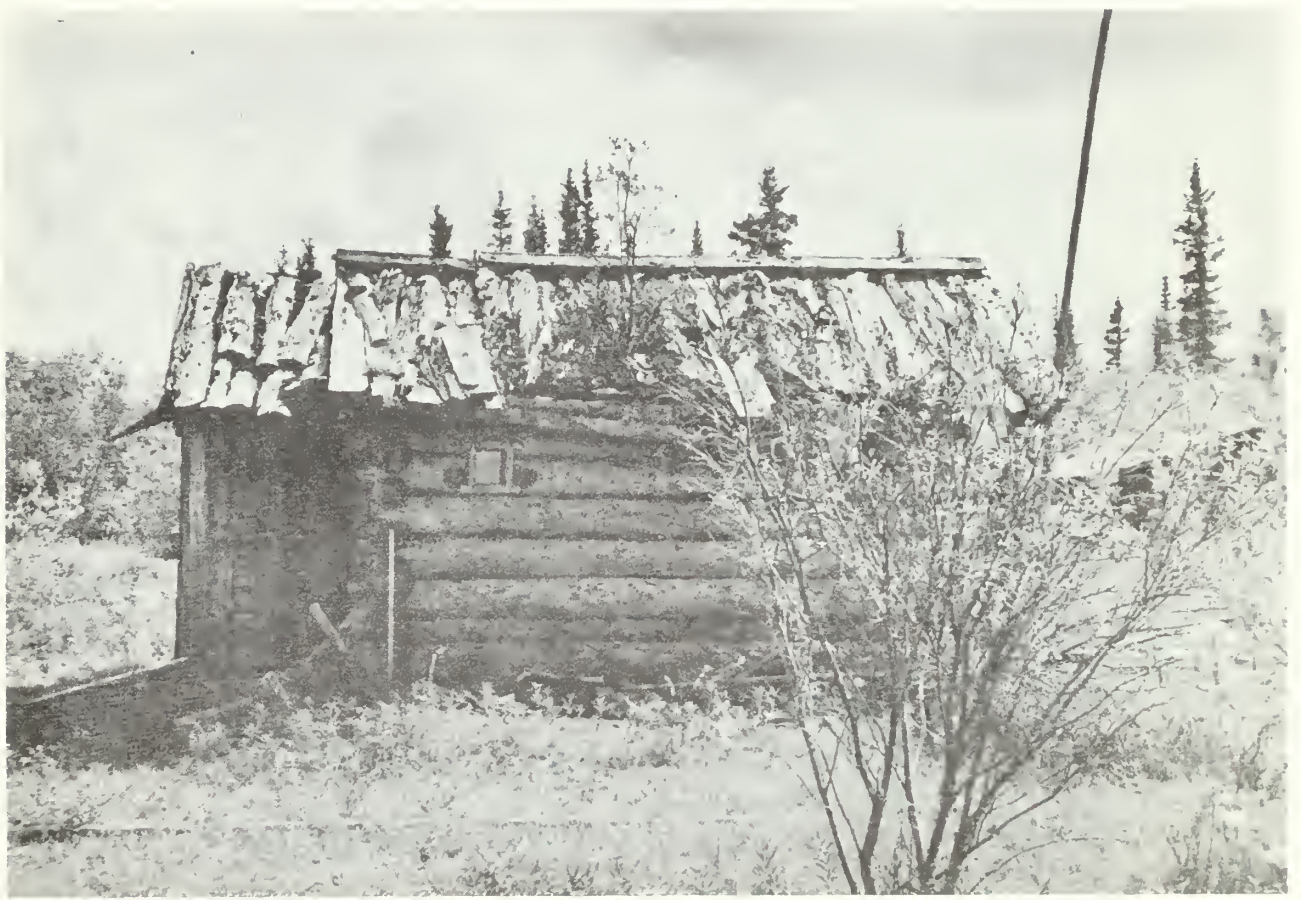
Photograph 5  
Women's Jail, Chisana  
North Elevation.

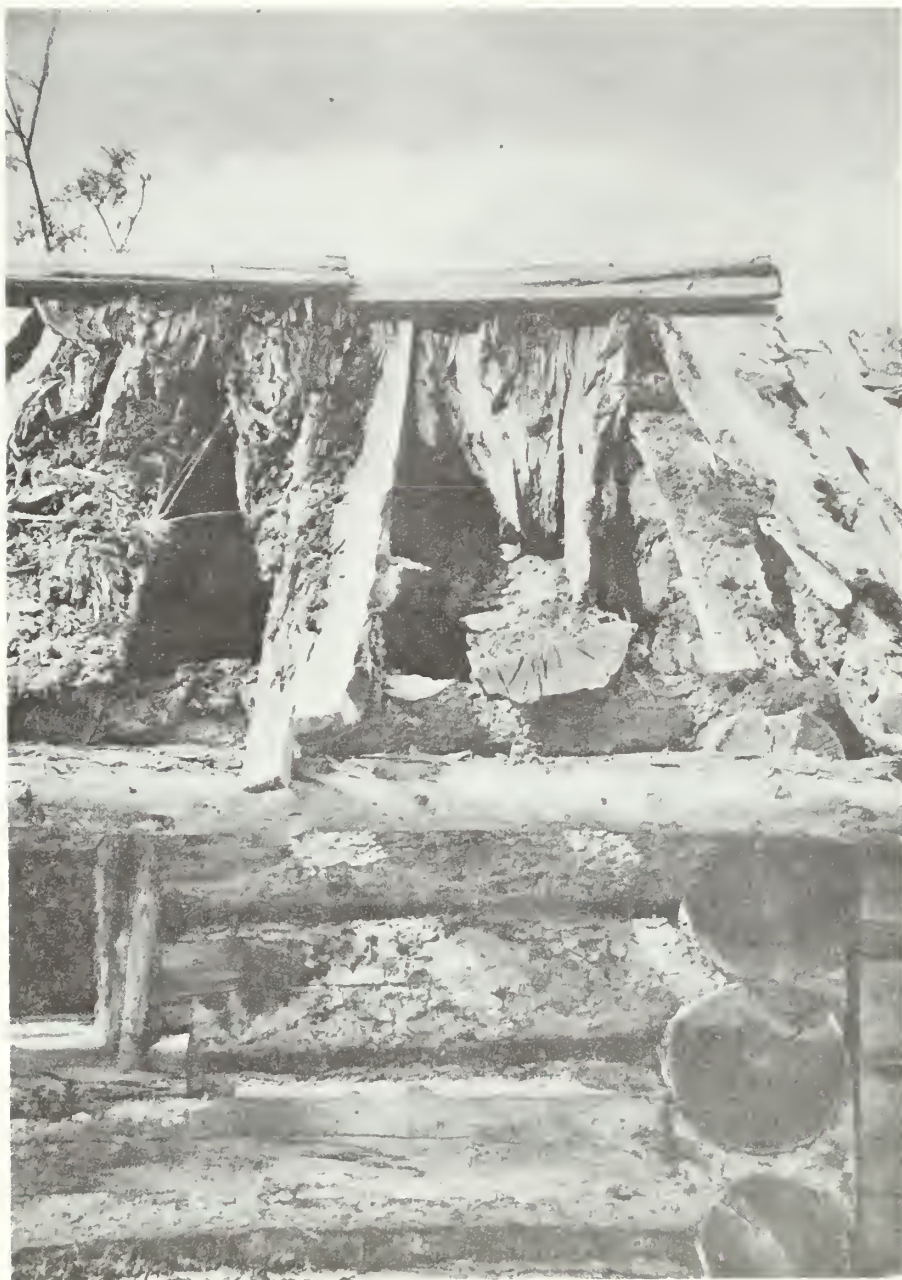
Photograph 6  
Women's Jail, Chisana  
"Hole-in-Roof" Detail, South Side.

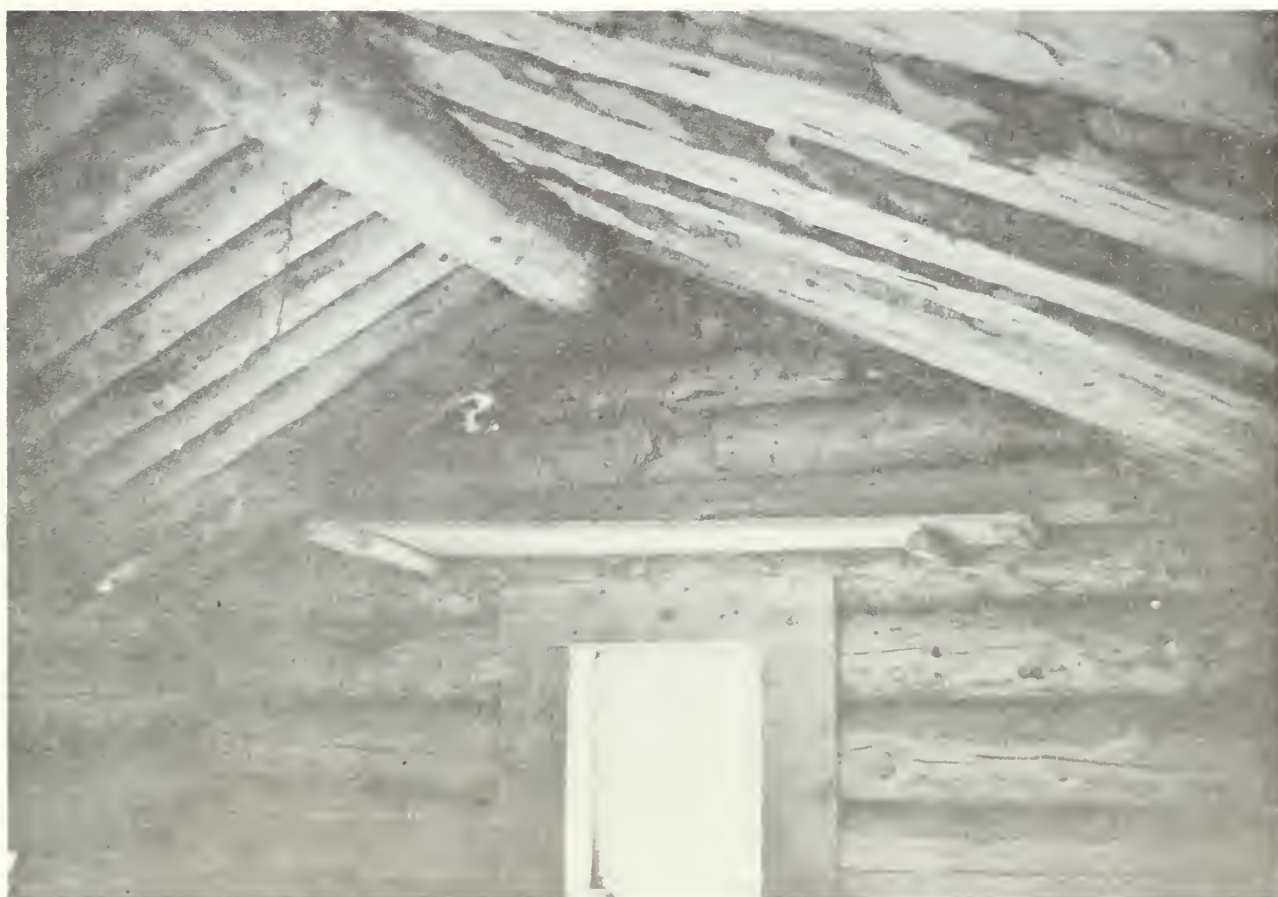
Photograph 8  
Women's Jail, Chisana  
Interior; West wall, shelf & window.

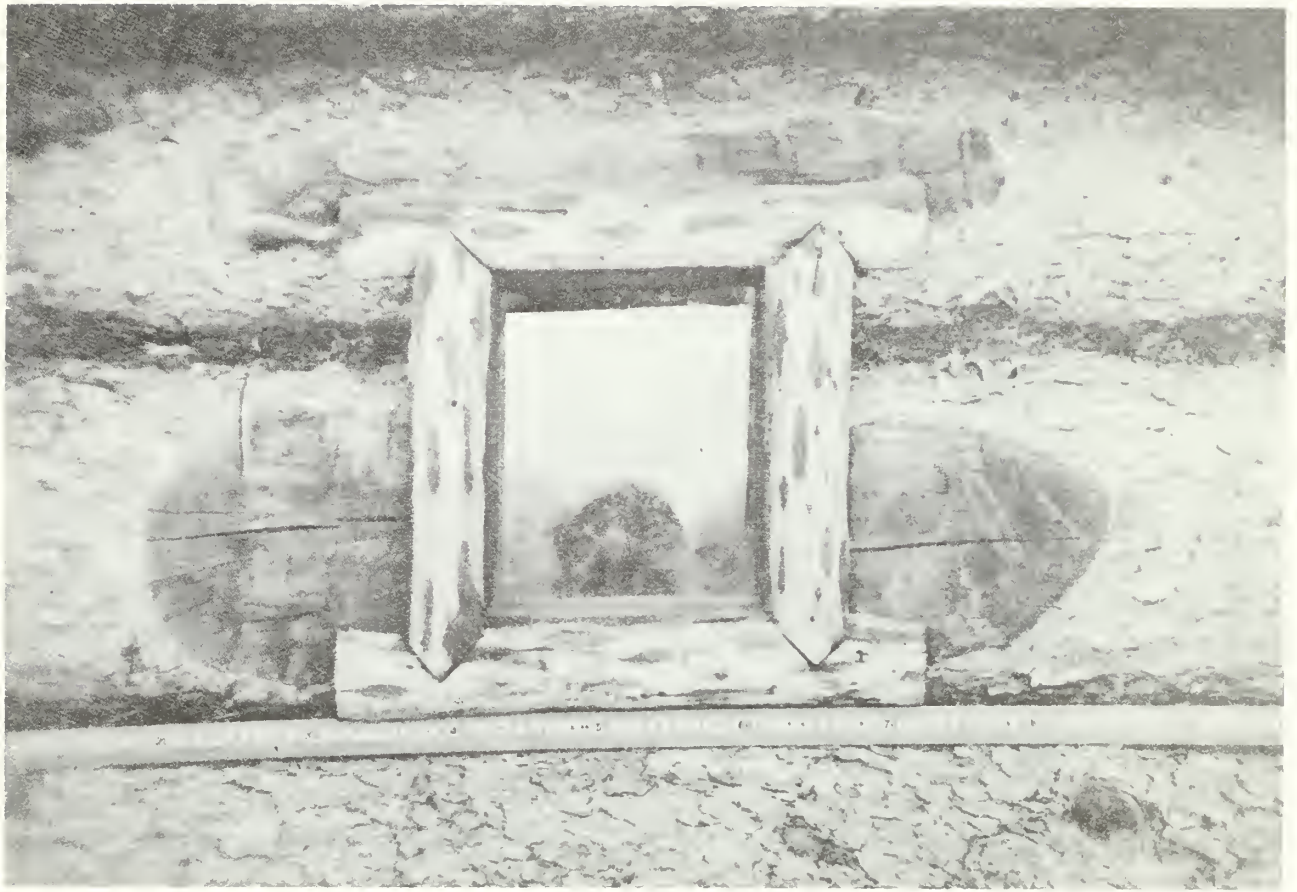
Photograph 9  
Women's Jail, Chisana  
Exterior; Window on north wall.

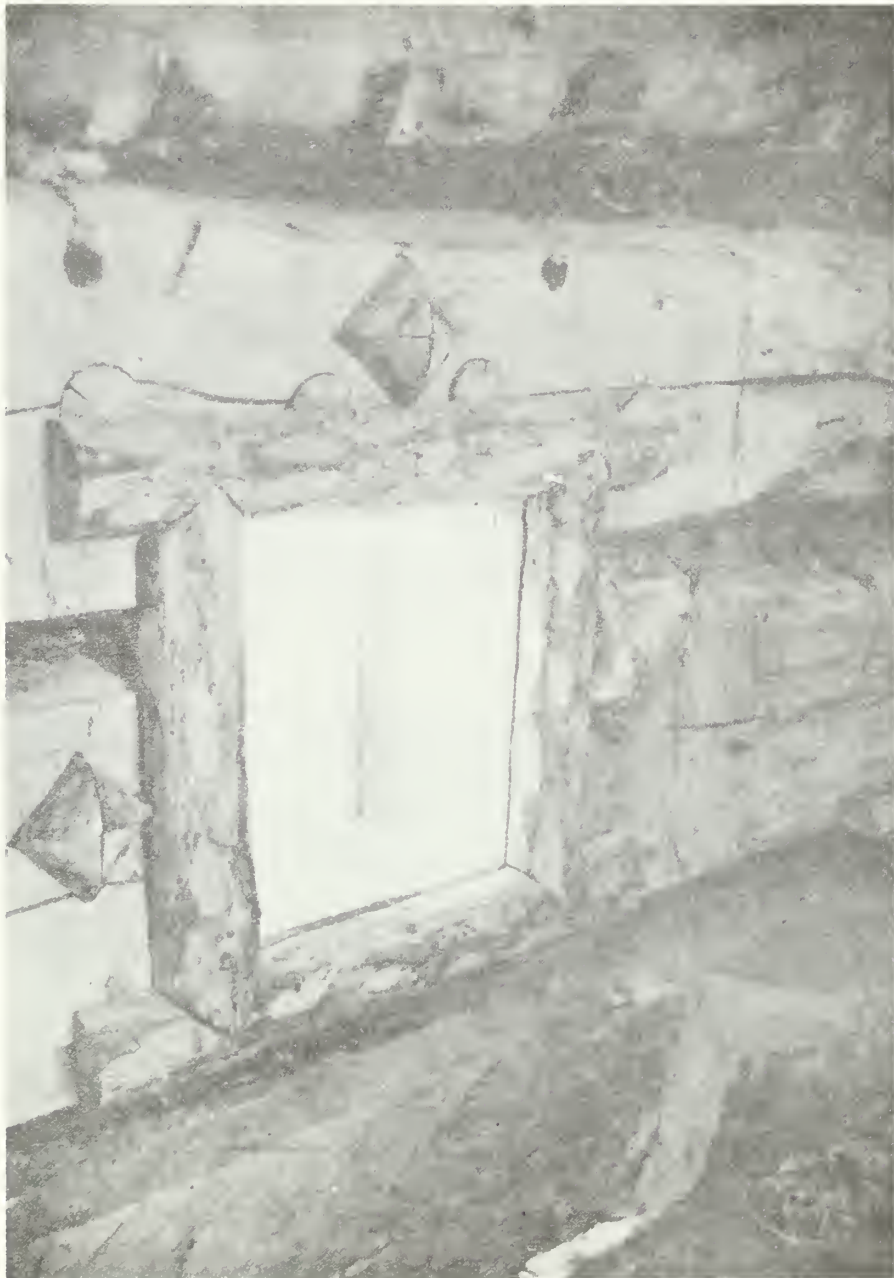
Photograph 10  
Women's Jail, Chisana  
Interior; Window on north wall.

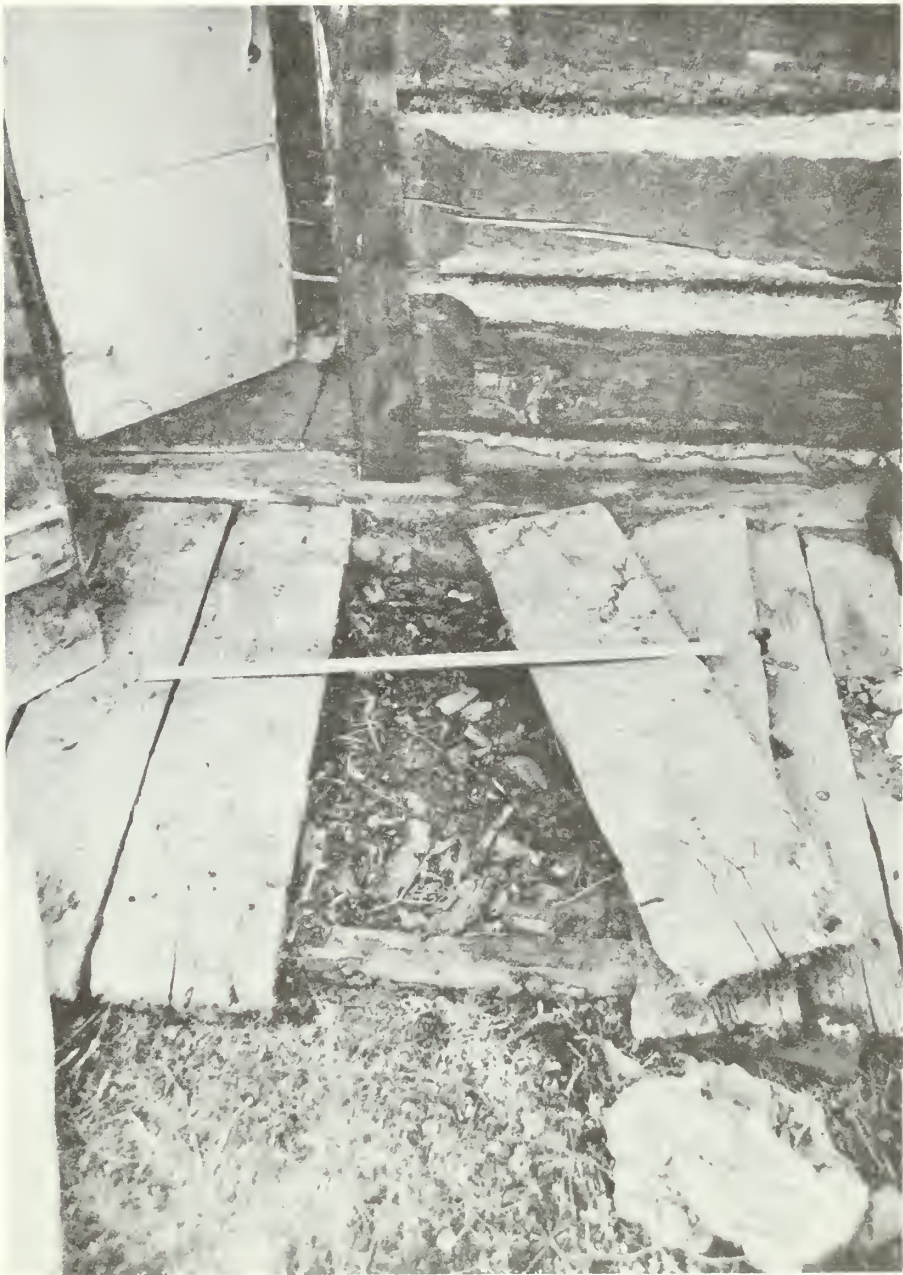
The porch floor is heavily weathered and deteriorating in places. The boards are loose and the two stringers underneath are rotting considerably.

Photograph 13  
Women's Jail, Chisana  
Floor planks, porch.

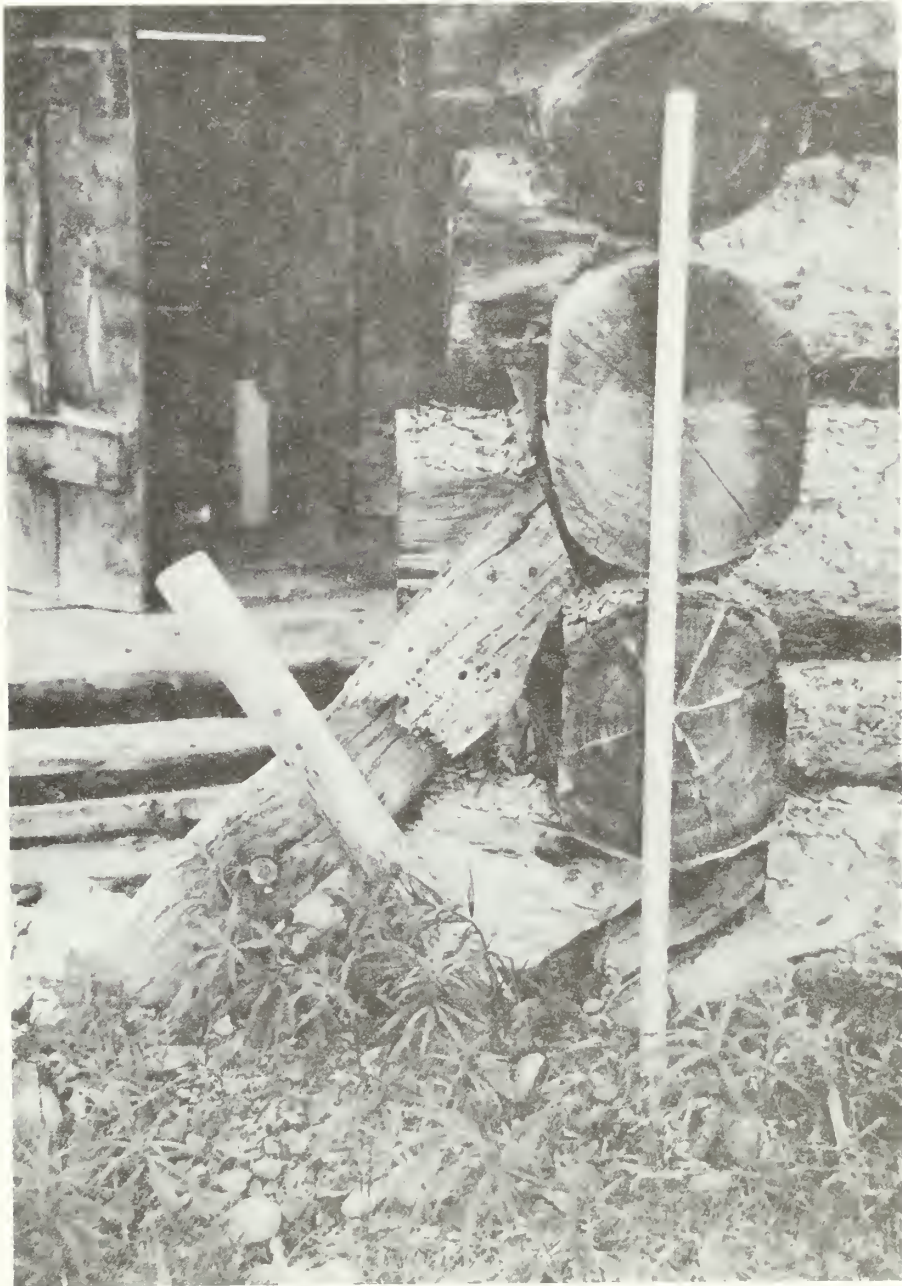
Photograph 14  
Women's Jail, Chisana  
Corner bracing at sill logs.

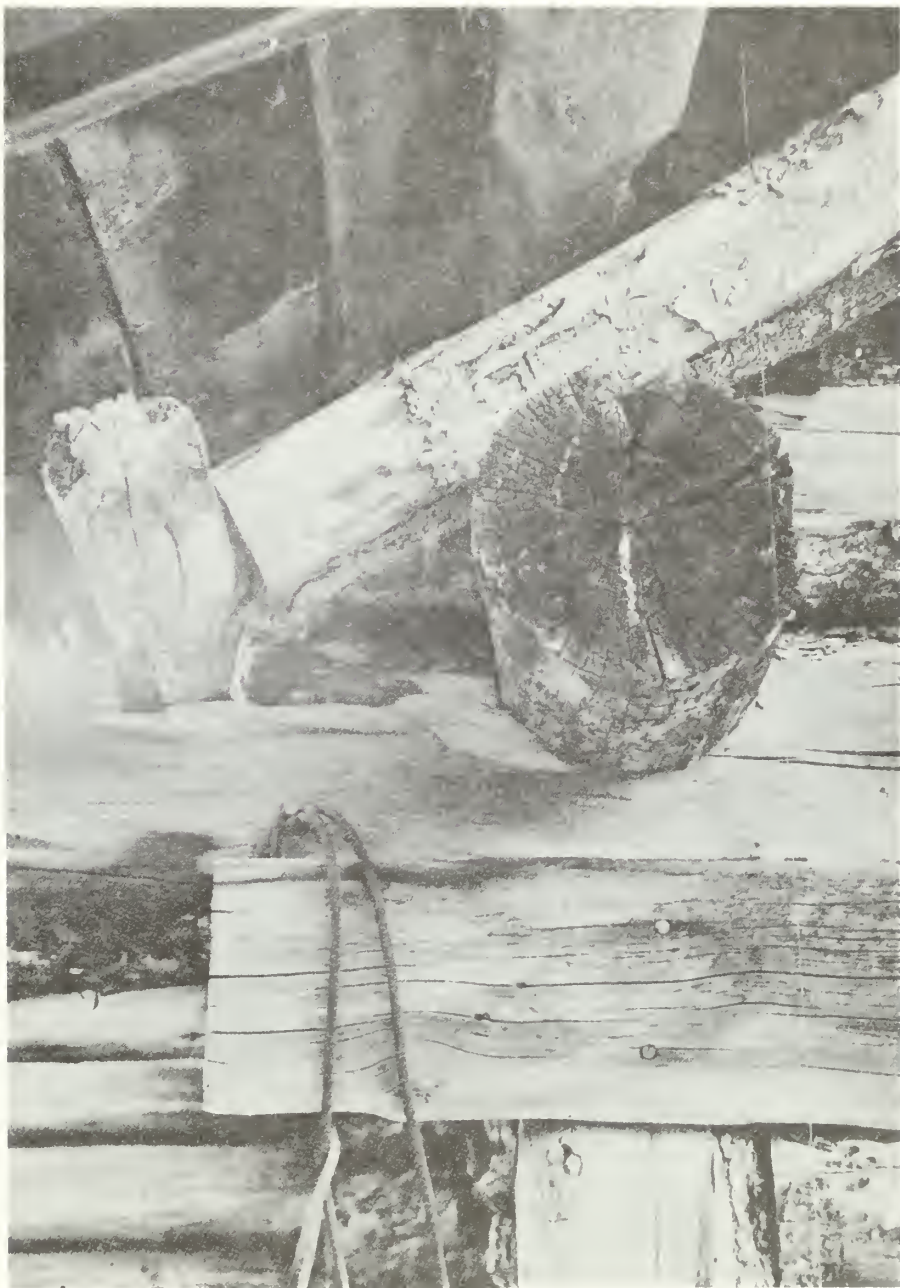
Photograph 19  
U.S. Commissioner's Court, Chisana  
Junction of the ceiling timbers,  
butting pole, eave log and  
plate log w/newer roof above  
ceiling members

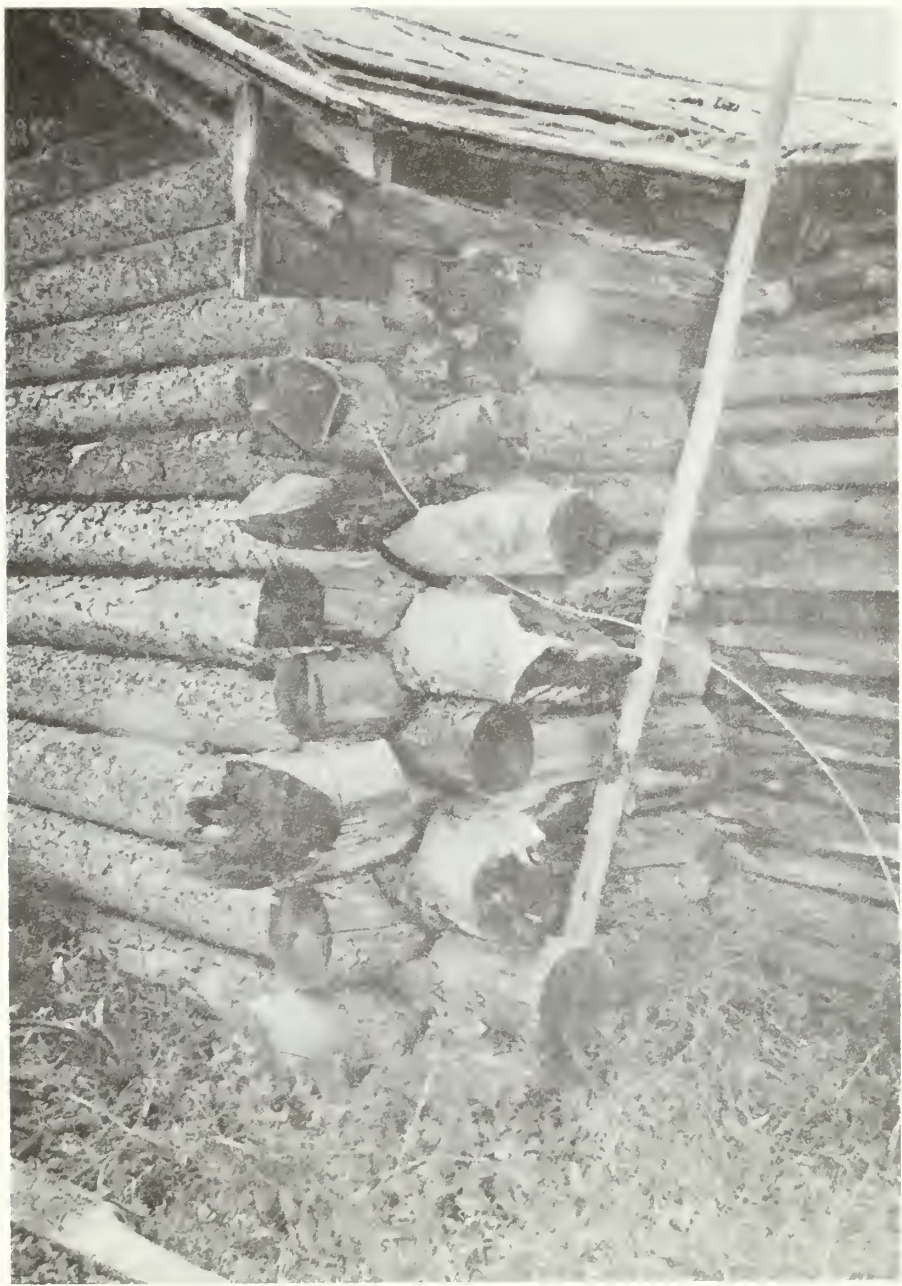
Photograph 20  
U.S. Commissioner's Court, Chisana  
V-notched log corner; showing  
junction of addition logs and  
newer roof.

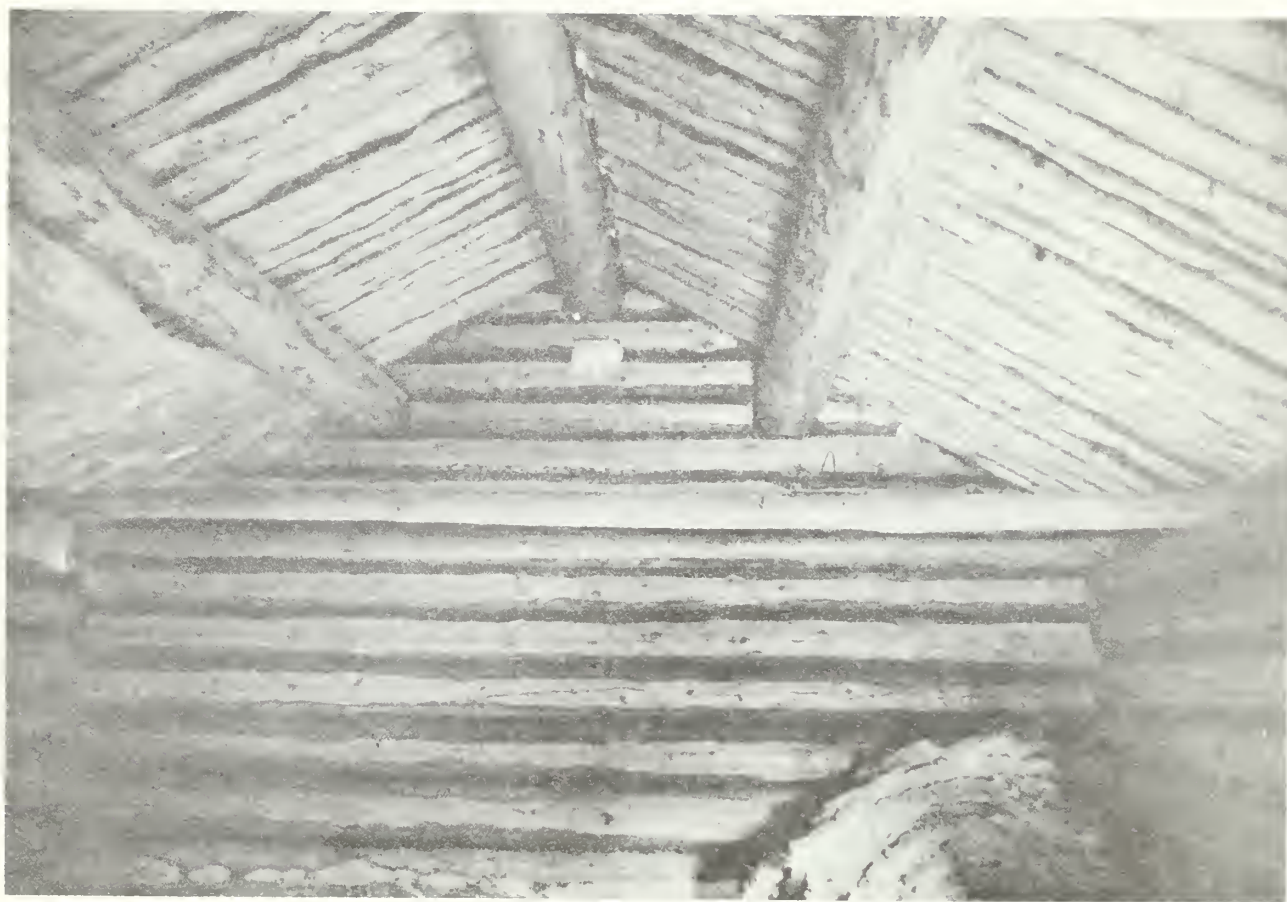
Photograph 21  
U.S. Commissioner's Court, Chisana  
Ceiling & North wall, showing split-  
log ceiling members and peeled  
purlines & ridge beam.

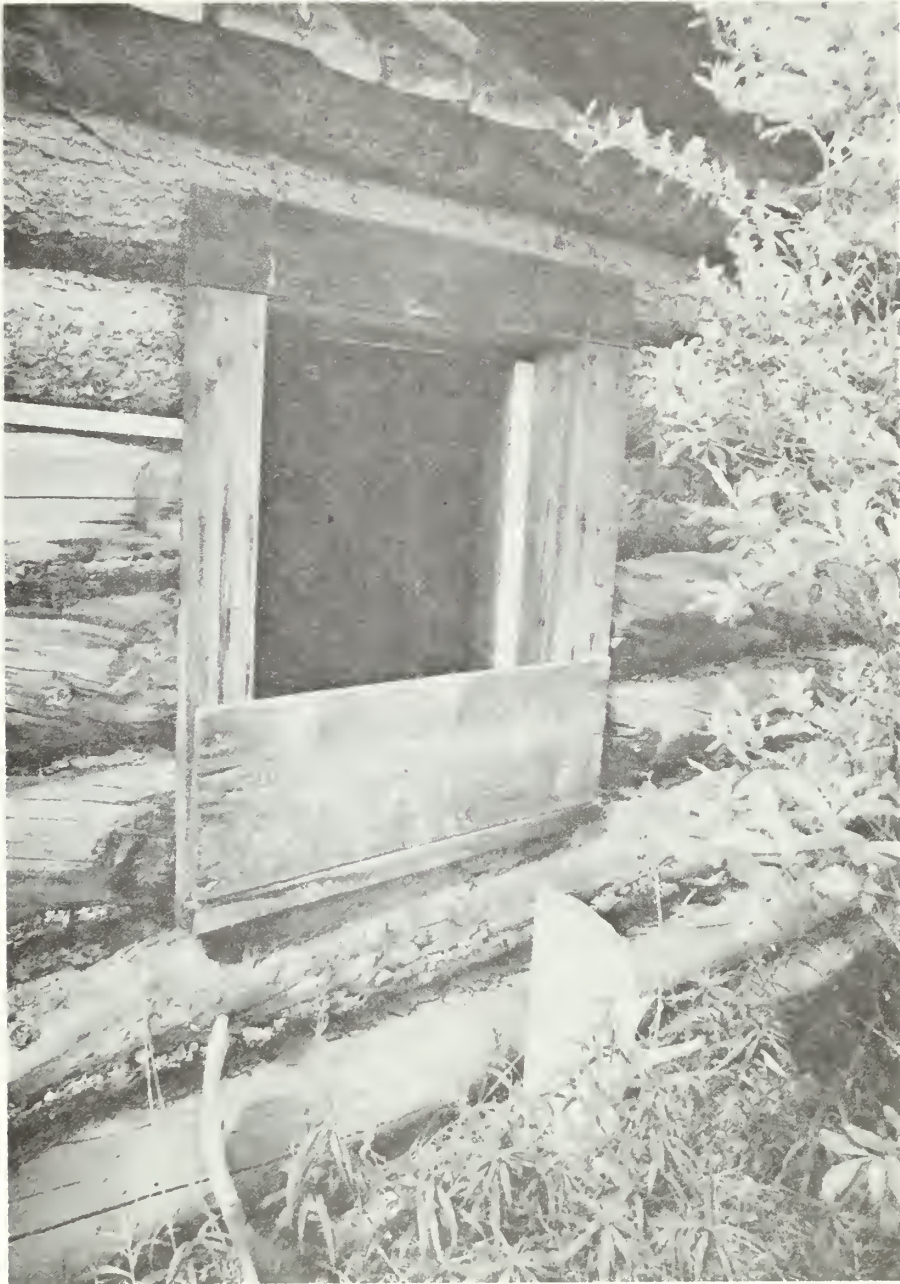
Photograph 22  
U.S. Commissioner's Court, Chisana  
Window in East wall - logs hewn to  
receive flat trim pieces.

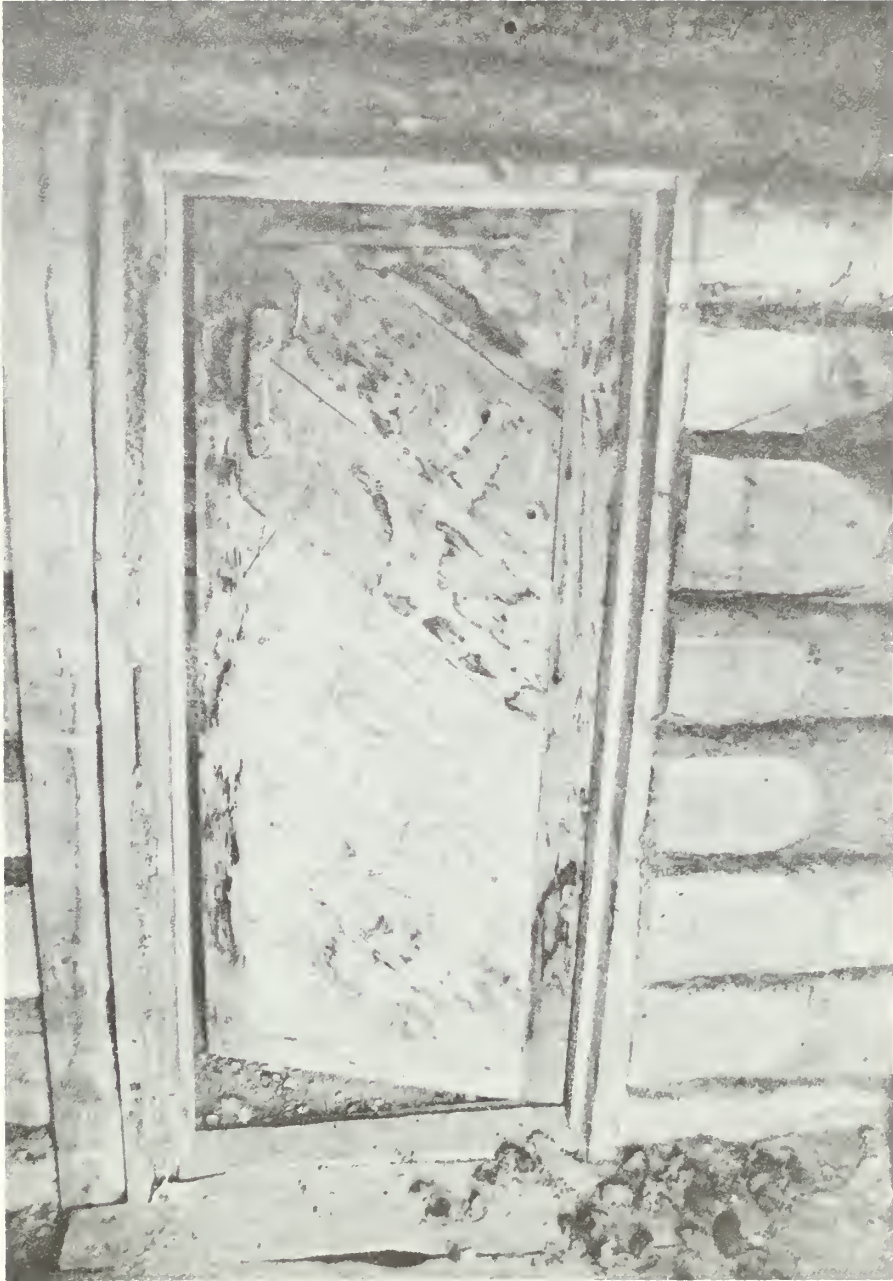
Photograph 23  
U.S. Commissioner's Court, Chisana  
Front entry to main cabin with hewn  
logs at trim; trim missing on  
right side.

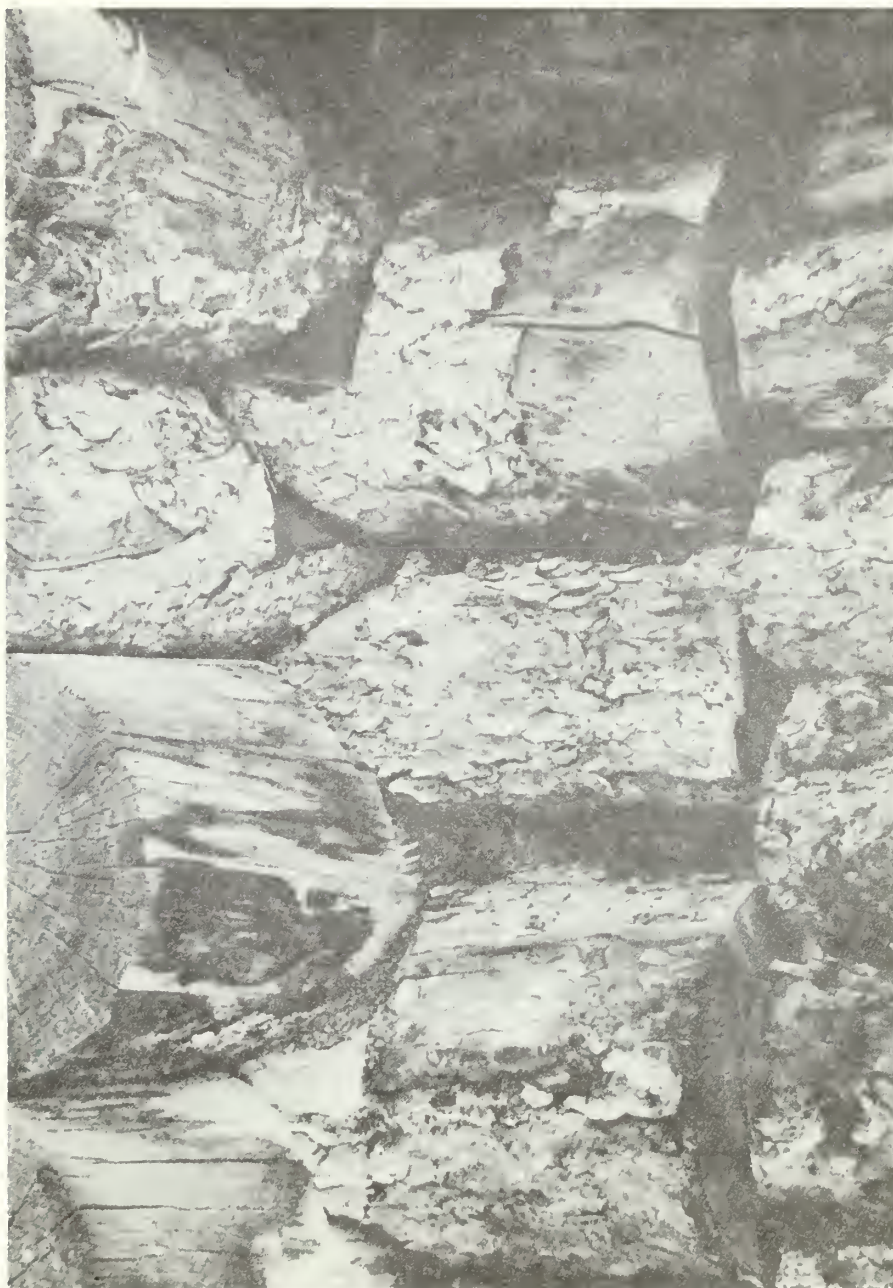
The joint between the main cabin log extensions and the porch wall logs consists of a spline nailed to the ends of the main cabin logs and notches in the porch wall logs (very similar to the Hudson Bay cornering). Splines are loose here also, but the joint is fairly tight. The chinking along this joint is also missing as it is through out the porch walls.

Photograph 24  
U.S. Commissioner's Court, Chisana  
Junction of main cabin logs and  
porch logs (spline just visible  
between second and third porch logs  
on right)

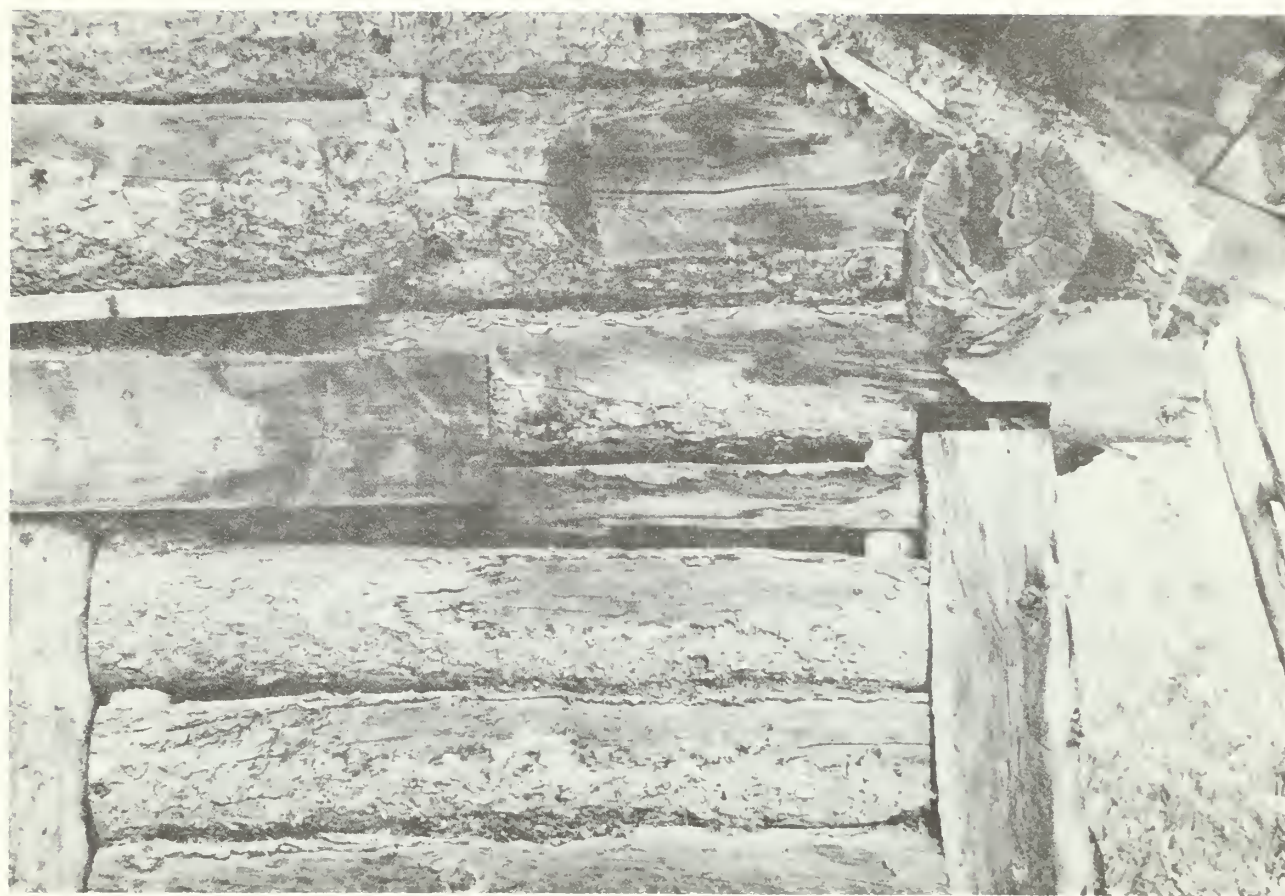
Photograph 25  
U.S. Commissioner's Court, Chisana  
Hudson Bay corner at front of porch,  
post dropping away from eave log.

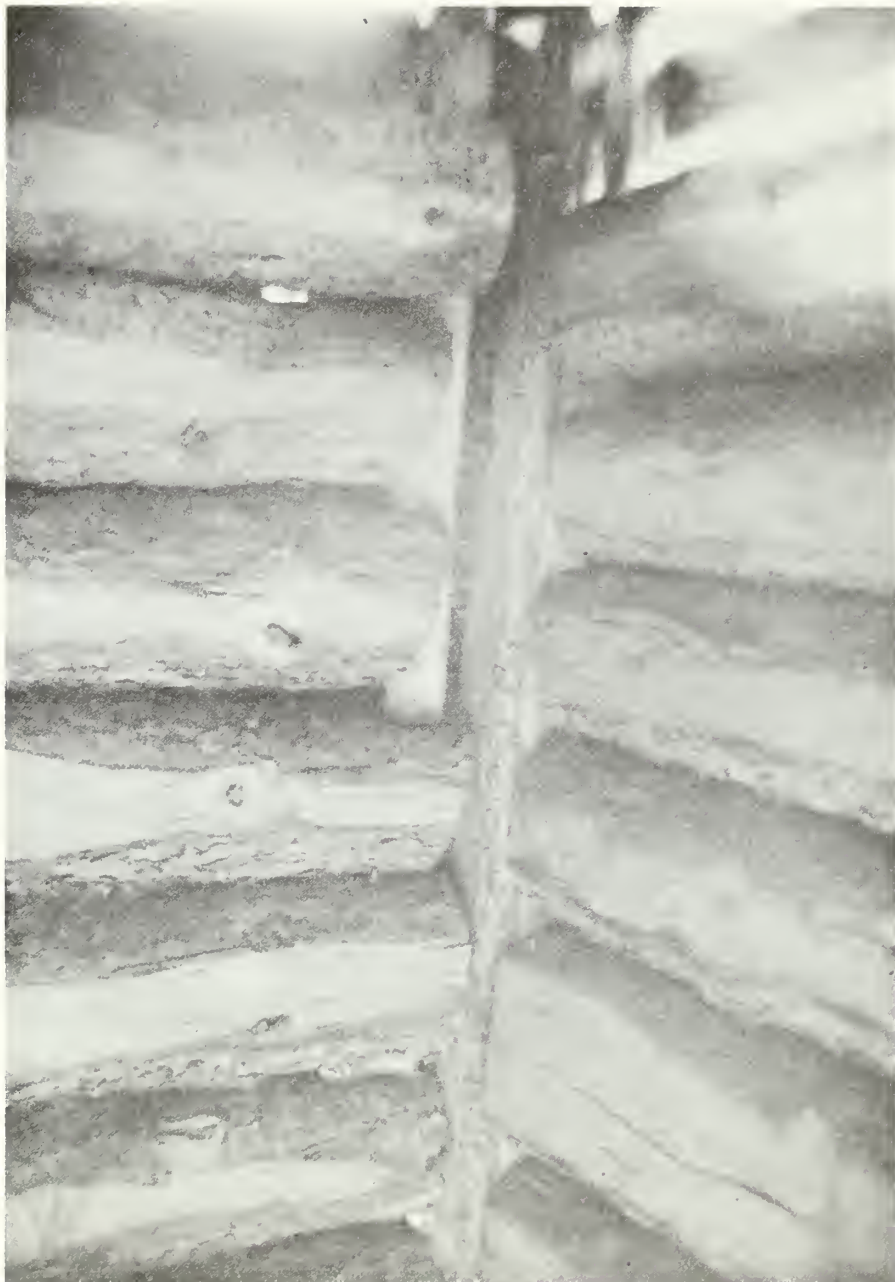
The porch walls consists of 5 1/2 inch-6 inch logs horizontally stacked with Hudson Bay corners. Corner splines are loose on most joints. Horizontal logs are notched around the splines but nailed to splines in very few places. Large cracks are opening up between logs toward the tops of the corner posts - due to settling of the outside corners (or potentially, to heaving under the door toward the center of the wall). The posts on each side of the door are similar in detail to the corner posts. The door posts are also notched into the eave log which doubles as the header log over the door.

Photograph 26  
U.S. Commissioner's Court, Chisana  
Detail of Hudson Bay corner and  
splines from interior of porch.

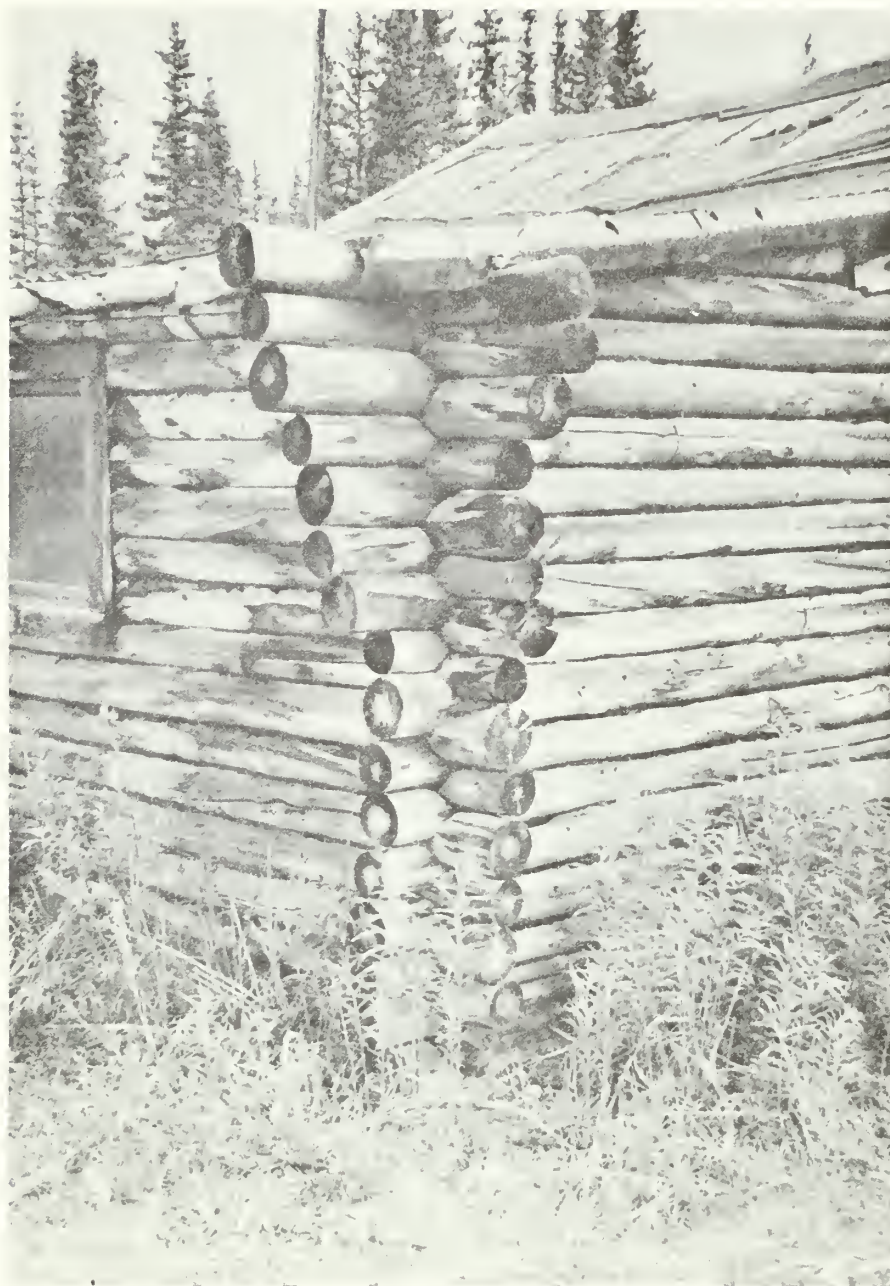
Photograph 27  
U.S. Commissioner's Court, Chisana  
Southwest corner of addition

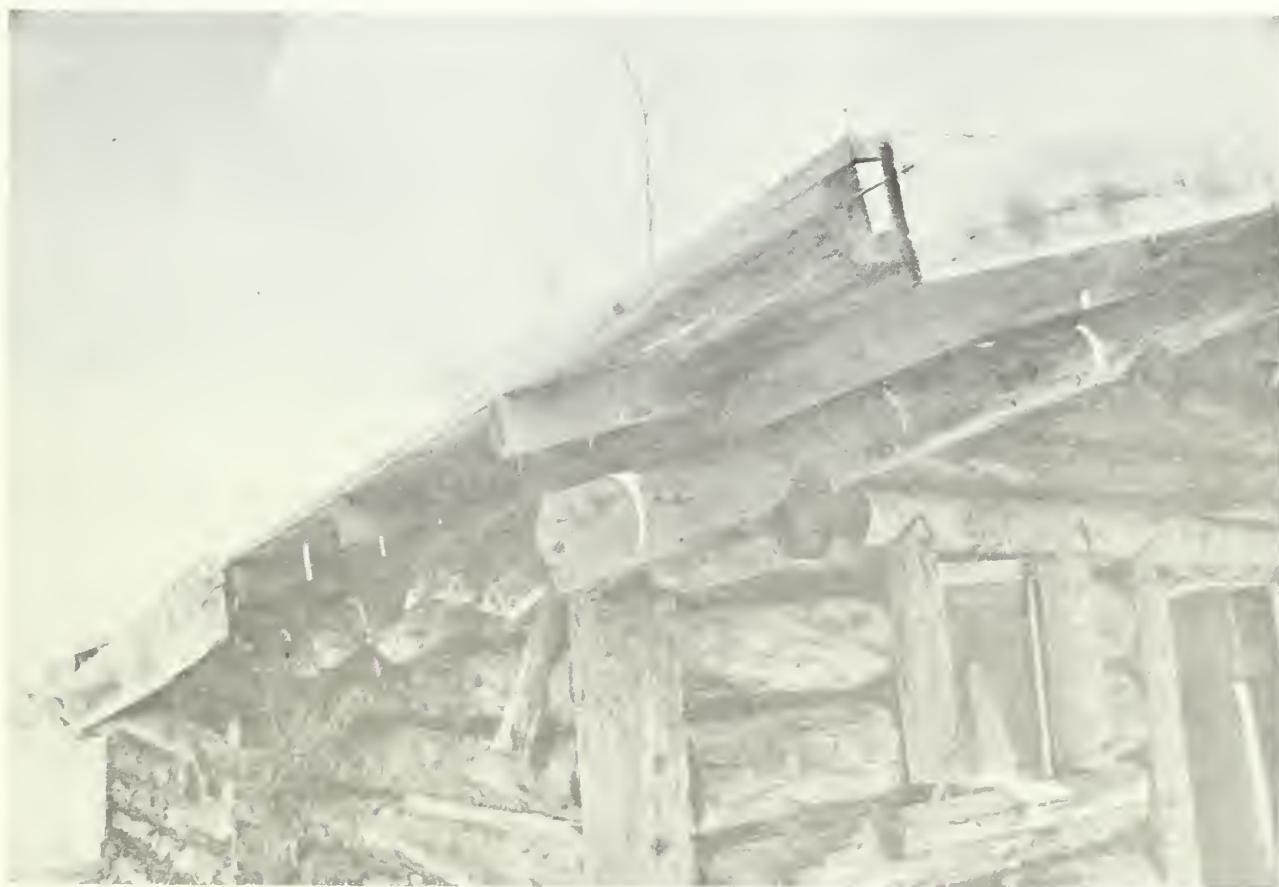
Photograph 35  
U.S. Commissioner's Residence, Chisana  
Eave detail with newer roof over decaying  
ceiling members (note sag in roof line).

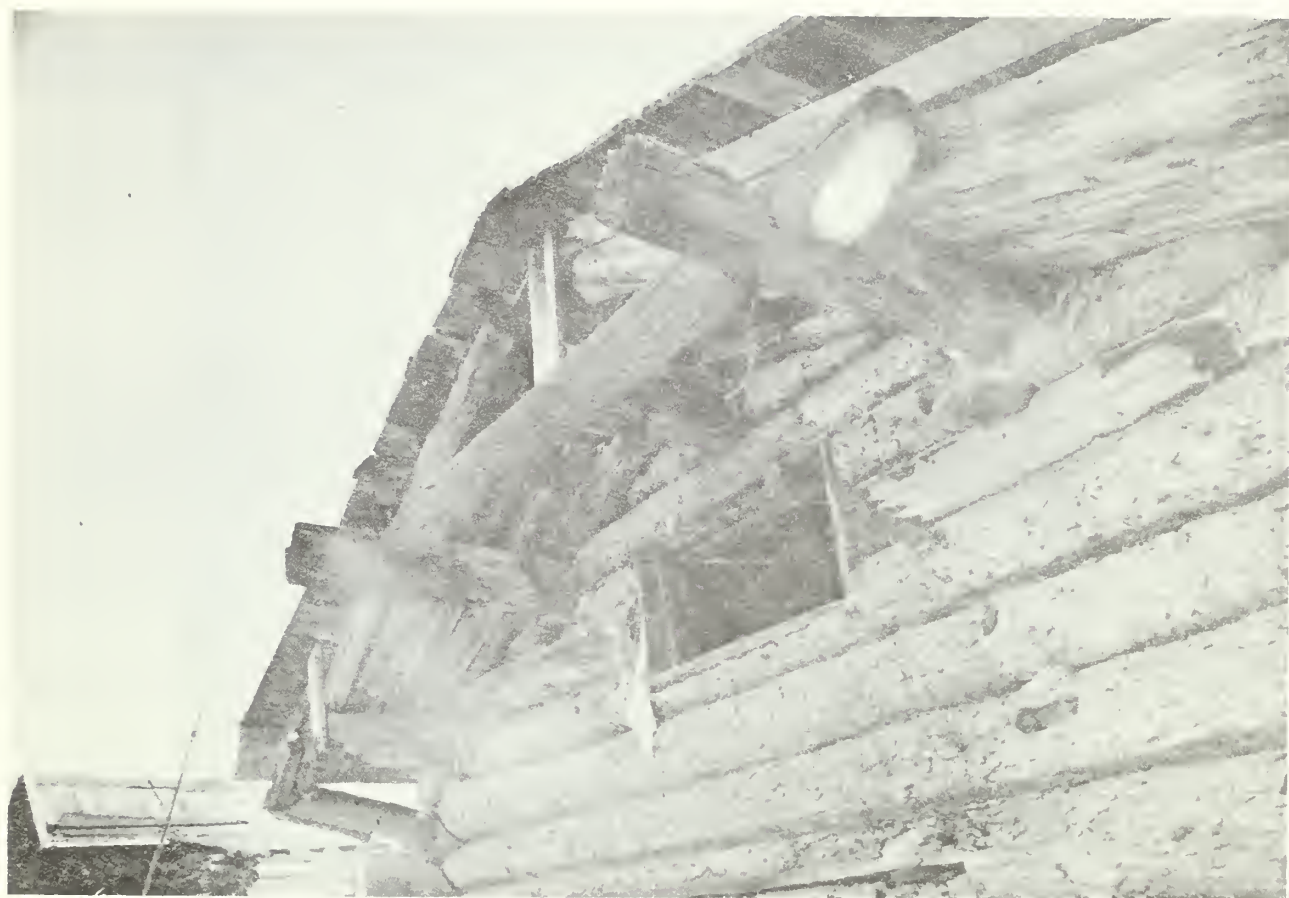
Photograph 36

U.S. Commissioner's Residence, Chisana  
Collar log connecting extended purlins  
(note 8" overhang of rewer roof).
